Frankton Parking Investigation

Queenstown Lakes District Council

Date: September 2017
Reference: 6-XQ064.01
Status: For Release. Revision 1

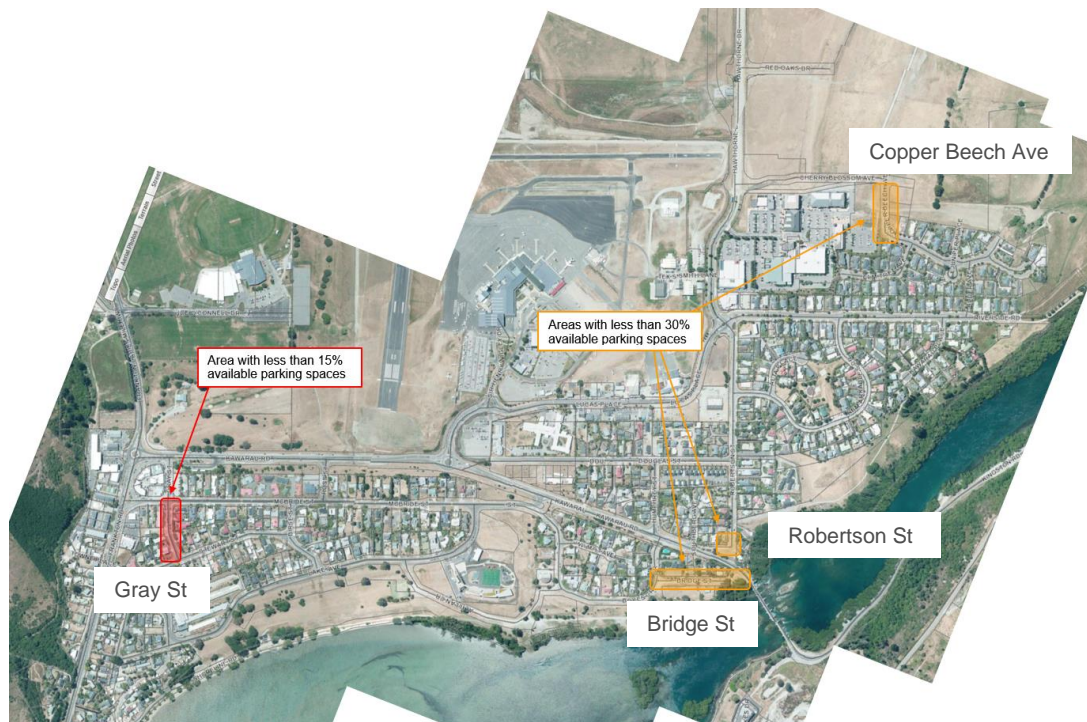
In general the on-road parking utilisation throughout Frankton was at less than 40% of capacity. Those areas at higher occupancy rates are shown in the image below.

Image 2: Areas of high density parking identified in September 2017 Investigation

It was observed that Bridge Street and Robertson Street both had significant amounts of commercial vehicles parked on them. The effects were heavily isolated and were centred at the SH6 Kawarau Rd end of both streets. It is assumed this was due to the current works on the new Kawarau Bridge, and therefore the heavy parking density will be a temporary effect only. It is also possible that the vehicles parked here are related to the Hilton complex.

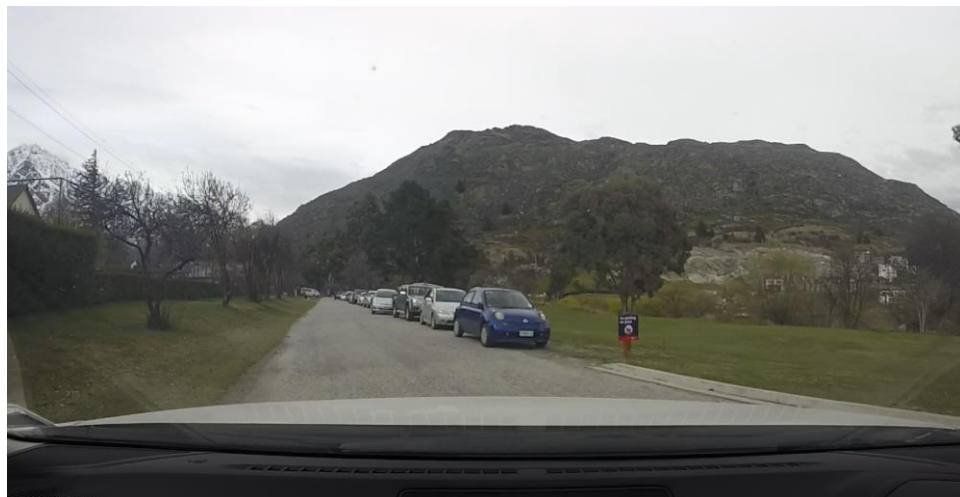
Bridge Street has displayed an increase in parking utilisation. Where previously the parked vehicles were limited to one end of the street in the cul-de-sac area, there are now vehicles parked along the roadside as shown below. It is unclear what the cause of the increased parking demand is, however it is suspected to be related to the Kawarau Falls Bridge construction works, as it is unlikely that the parking demands from residents in the area would increase significantly over just 5 months.

Image 4: Bridge Street in September 2017 Investigation (Note sign on right hand side: "No parking on grass")

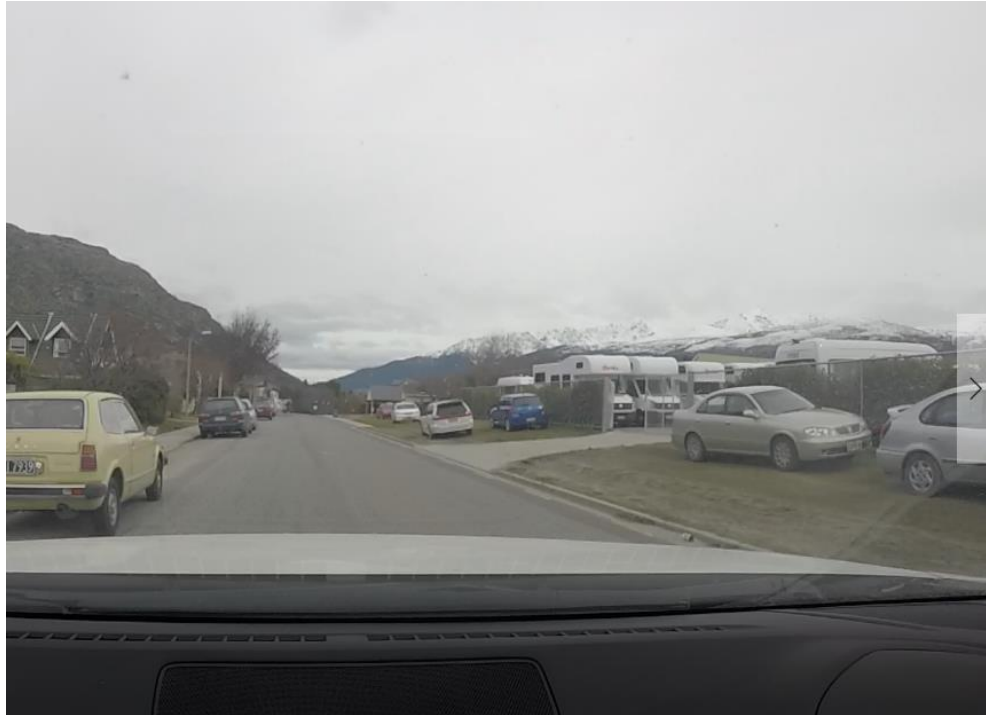
The section of Robertson Street between Riverside Road and Douglas Street often had vehicles parked on the grass verge on the north side of the road. This may cause safety problems due to the manoeuvres required to mount/leave the shoulder, reduced visibility due to the vehicles parked on the shoulder, and may also be considered a maintenance/amenity issue as the vehicles are likely to damage the grassed area.

Image 5: Parking on grass verge along Robertson Street

1. Increase the level of enforcement – it was noted by the Frankton Community Association that there appeared to be low levels of enforcement. Increasing enforcement will help to deter the unsafe practices. However, there needs to remain a base level of enforcement that continues to deter the unsafe practices. If the enforcement reduces over time, it is likely that the same issues will return.
2. Improvements to marking and signage – improving the signage and marking will assist the enforcement and further prevent unsafe parking behaviours. Similarly, it helps prevent a flouting of the rules such as on Peninsula Road (image 6) where the vehicles are parked behind the no parking lines, which is sometimes performed legally, but it is assumed that no parking is desirable in this location.

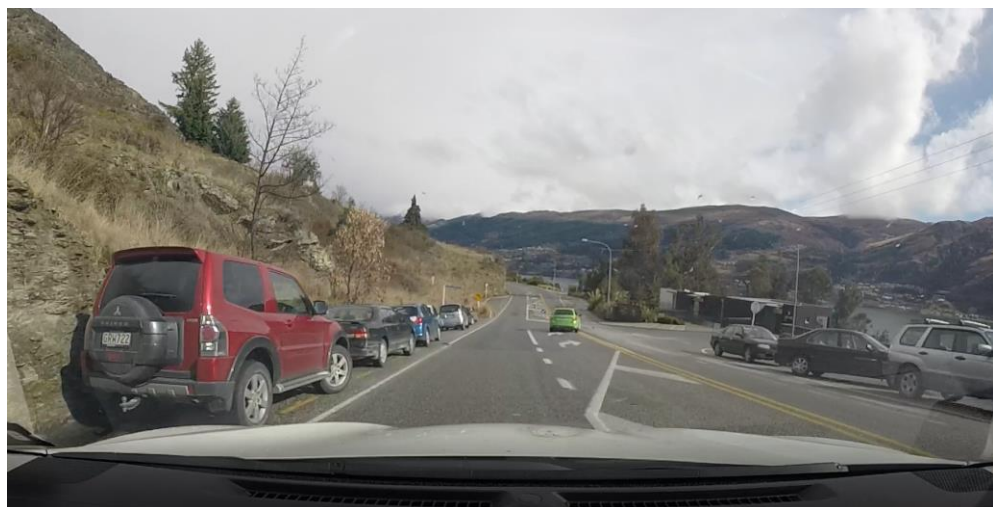
Along Peninsula Road, near the intersection with the Hilton/ Kwarau Village Road, there was a relatively high level of parking density. In this area parking on yellow lines was observed multiple times, as well as a mix of parallel and angled parking in the wide shoulder on the Northern side of the road. Angled parking may present a safety hazard as it is often difficult to see if the road is clear of vehicles before reversing into the live lane. While occasionally parking near the yellow lined areas was observed to be legal (i.e. more than one meter outside the yellow lines), in general there is not enough shoulder width to park safely, especially with the vertical and horizontal alignment of the road reducing the visibility for oncoming cars to identify people leaving/entering the parked vehicles.

If parking on the northern side of the road continues to encroach on the Hilton intersection, it may present visibility issue for vehicles exiting the Hilton complex, however there currently did not appear to be an issue, particularly given the low volume of vehicles expected to be performing right turn manoeuvres out of the Hilton complex.

Image 6: Parking on yellow lines, and mixed angled/parallel parking near the Hilton Hotel on Peninsula Road

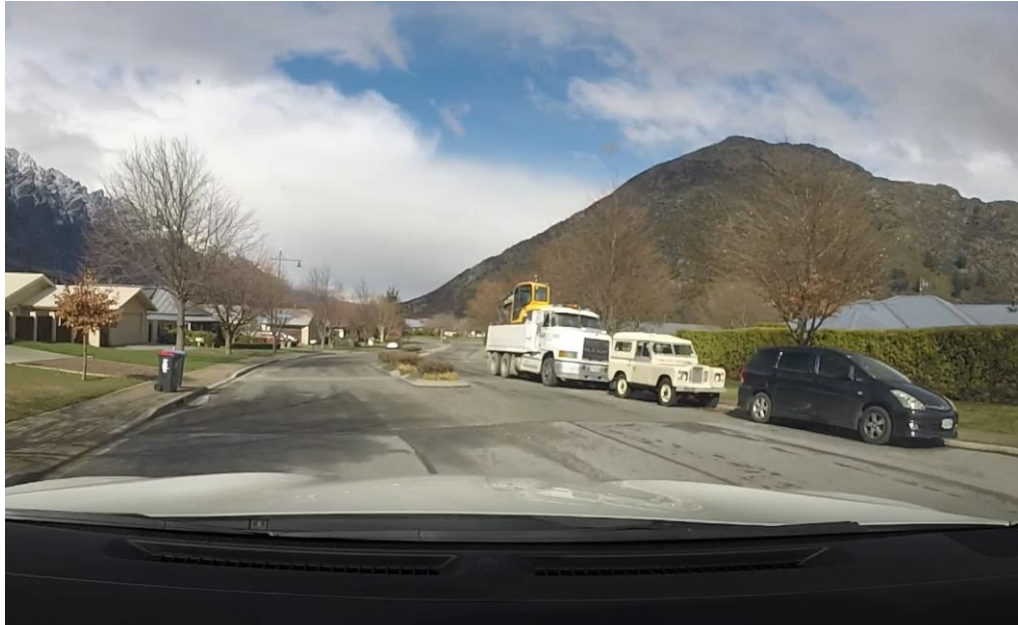
Along Copper Beech Avenue, a large vehicle was observed to be parked on the roadside in the same location as a median island/ pedestrian refuge island. The vehicle parking here reduced the trafficable lane width significantly, while also blocking pedestrian access to the median island for safe crossing.

Image 7: Heavy Vehicle parked on Copper Beech Avenue

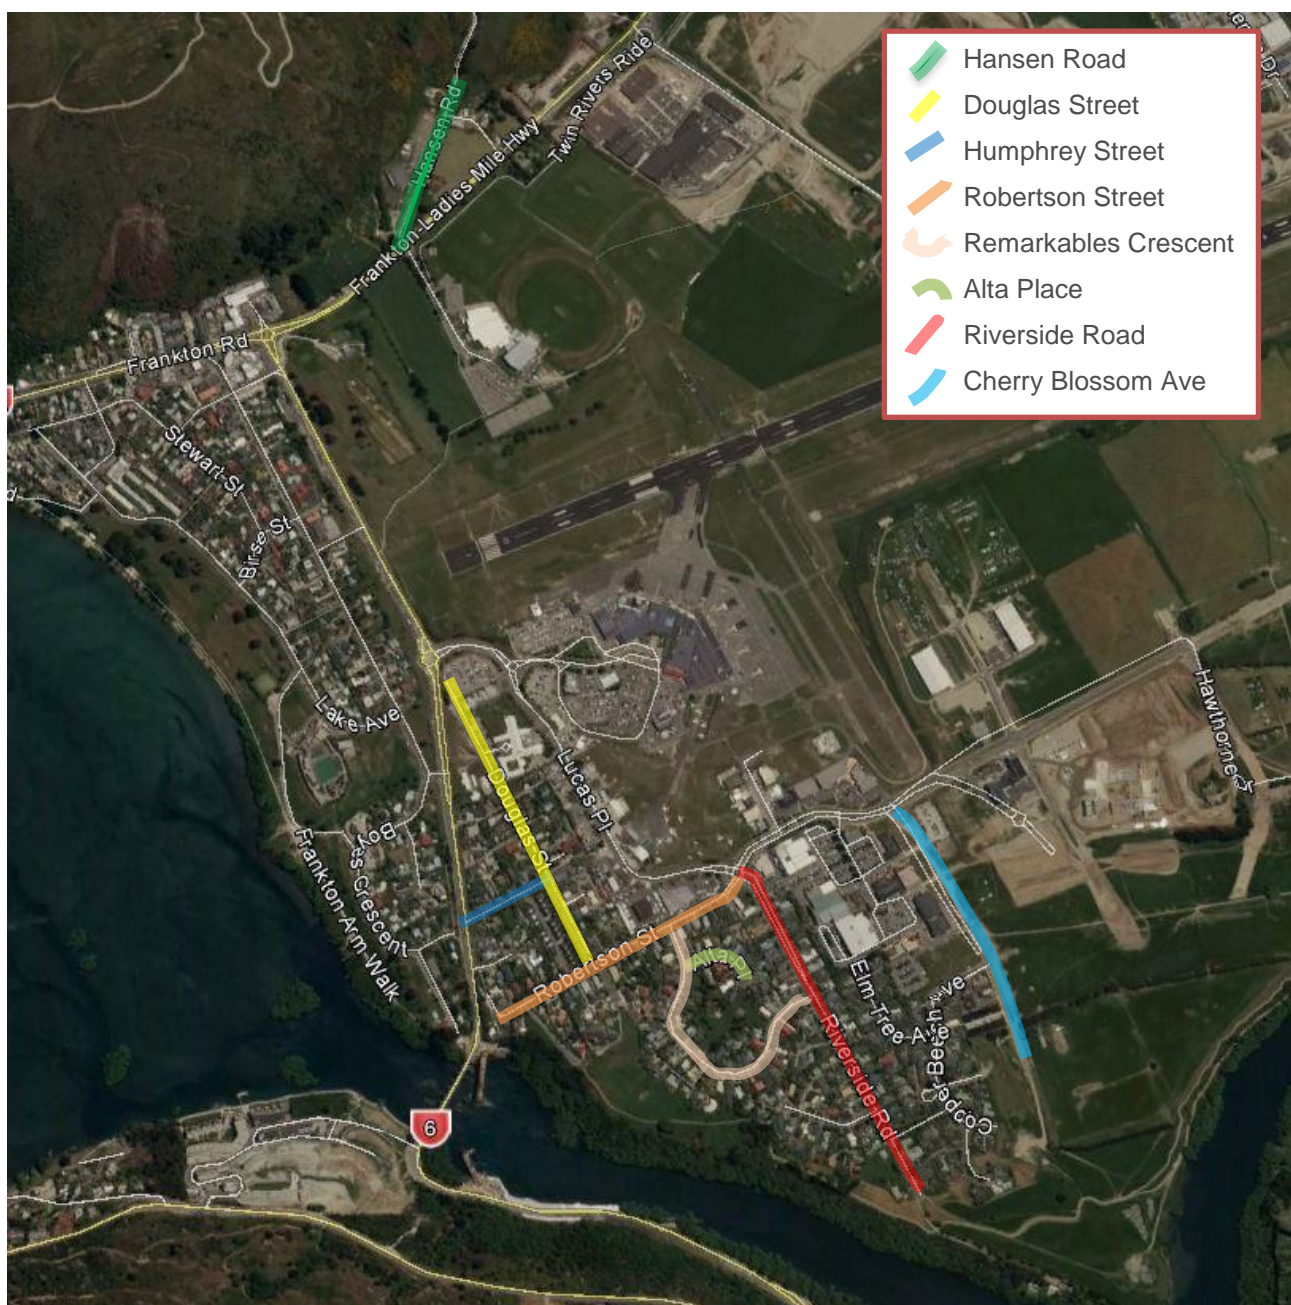
Figure 1, Streets monitored by QLDC enforcement officer
